Visual Termite Inspection Report in accordance with AS 3660.1/2/3-2000

Prepared For:	83 King Street Annerley QLD 4103
---------------	-------------------------------------

Client Information	
Client Name:	
Client Address:	83 King Street Annerley QLD 4103
Client Email	
Date of Inspection:	22/1/2024
Any active Termites found:	No, live activity was not found

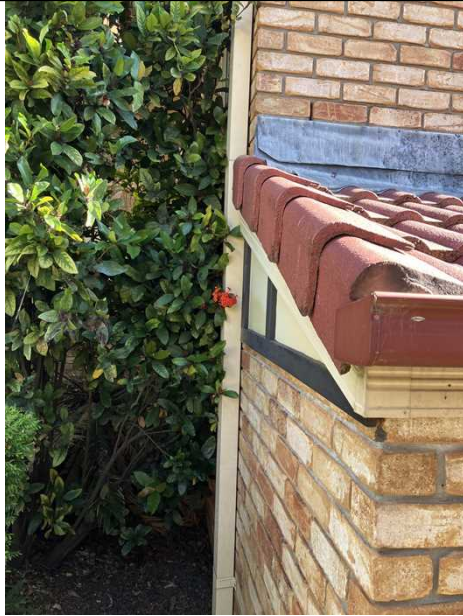
Garden bed and heavy foliage against building

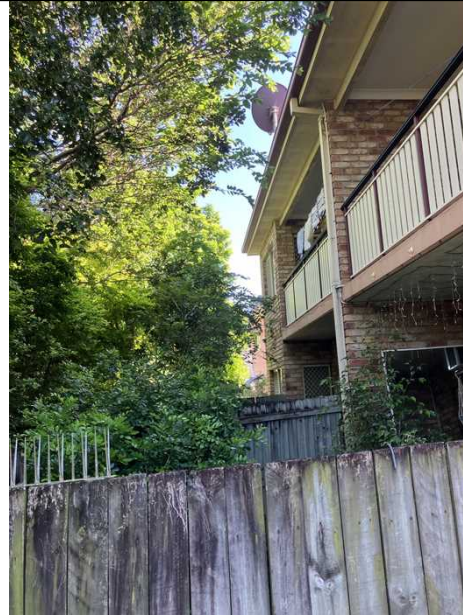
Foliage against building

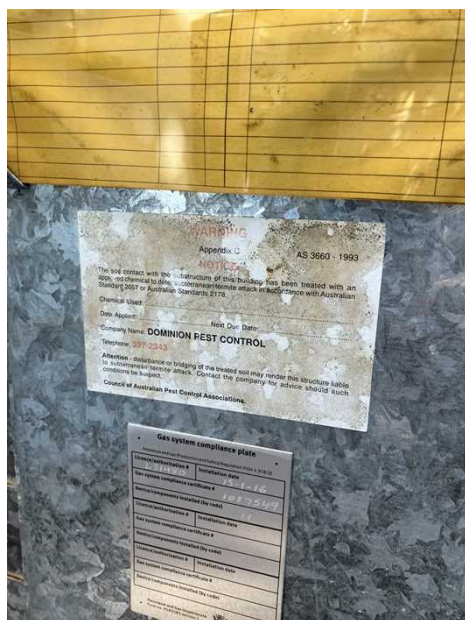
Evidence of a possible previous treatment was found:	Possible. Sticker in meter box is unrecognisable
--	--

Durable Sign

This indicates that none has been installed. This firm can give no assurances regarding work that may have been previously performed by other firms.

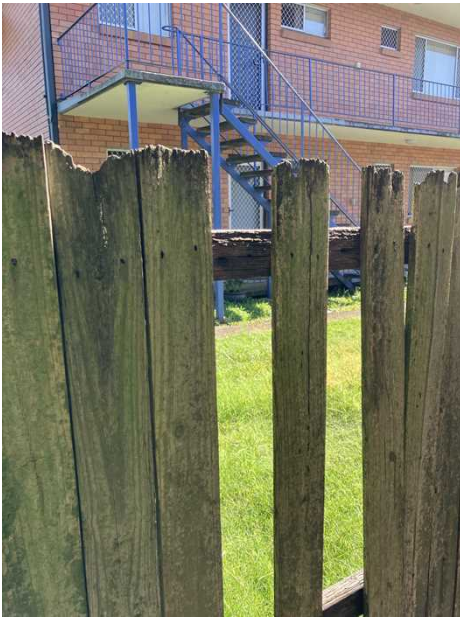
found?	
Evidence was located in:	Timber fences and landscaping timbers

Wood rot in timber fence

Wood decay fungi are conducive to subterranean termites. You should consult a builder or other building expert to find out what must be carried out to prevent further decay (repairing of drainage, leaks and/or sealing the timber) and to repair the damage.

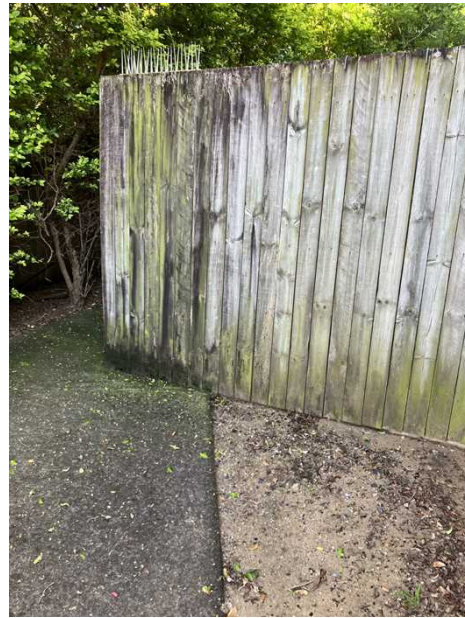
Fungal decay in timber fences

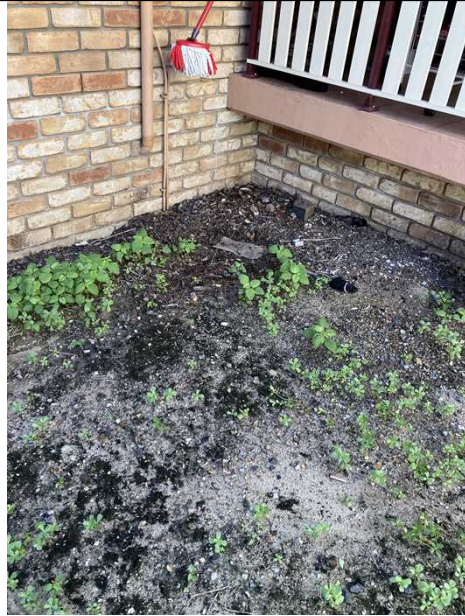
Garden beds against building walls

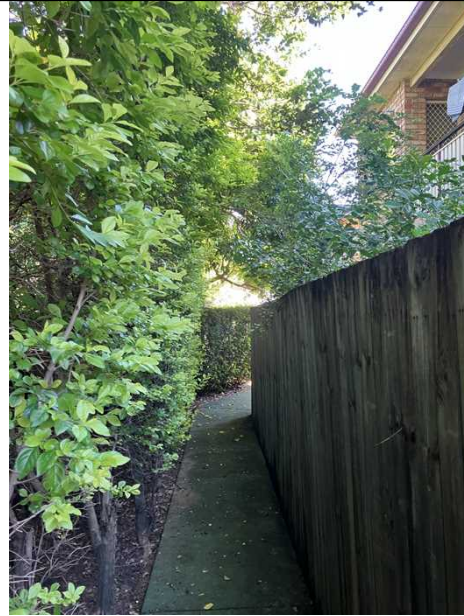
Heavy foliage against building

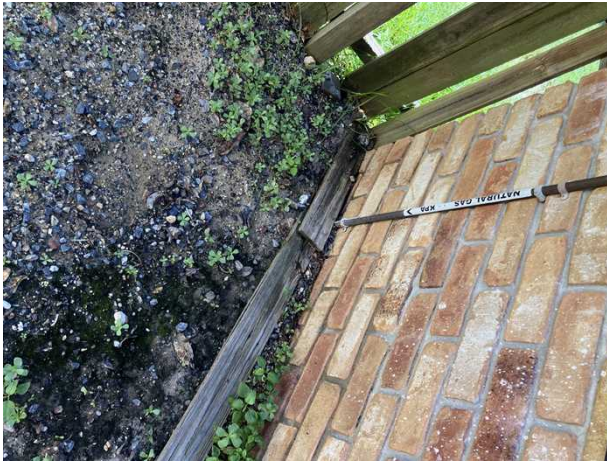
Stored timber against building walls

All timber in contact with soil such as formwork, retaining walls, scrap timbers, firewood or stumps must be removed from under and around the buildings and any leaks or poor drainage repaired. You should endeavour to ensure such conditions DO NOT occur around your property.

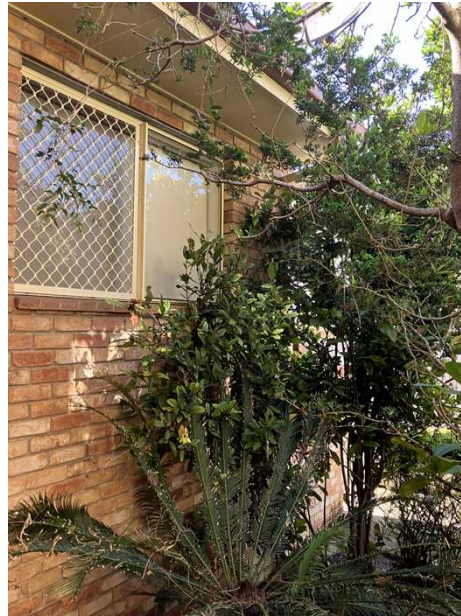
Foliage against building

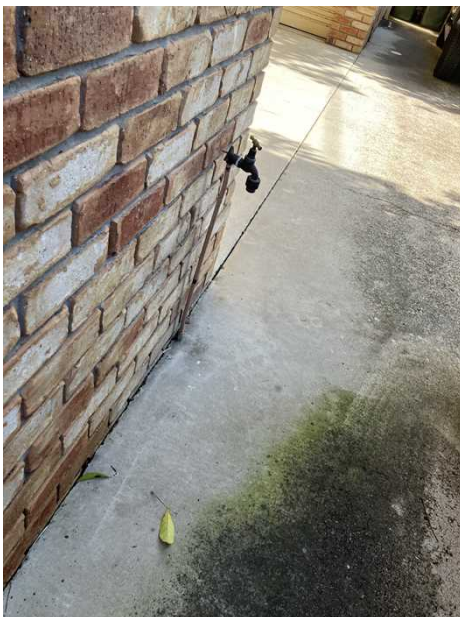
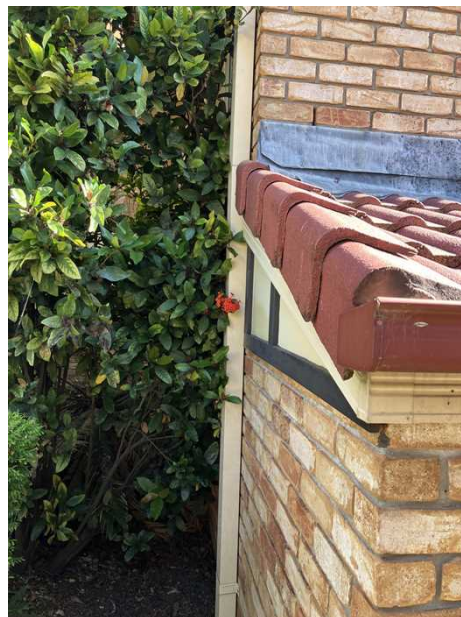
Tap draining directly onto ground and building walls	Garden bed and foliage against building walls
--	---
