# STANDARD TERMITE DETECTION REPORT

Report number: 005330

Inspection date: 30 April 2024

Property address: 2 Harvest Street Mansfield

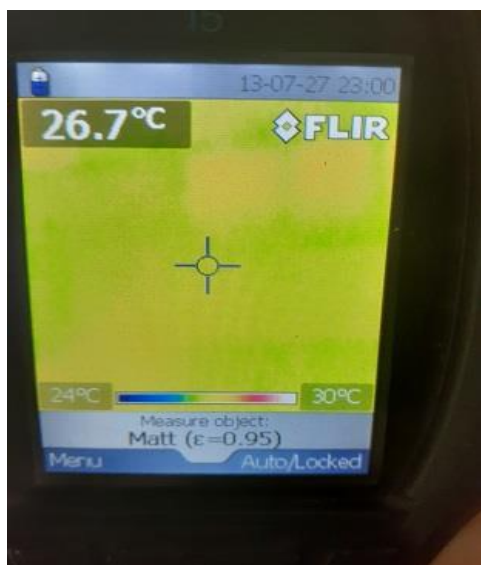
No evidence was found.  
at time of inspection

Thermal camera scan completed at time of inspection to internal cavity walls.

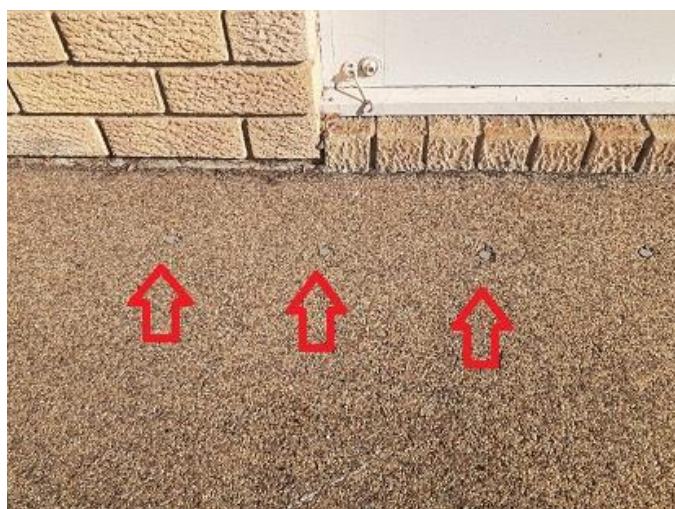
Previous treatment completed by Pestcall Australia completed 01-03-2021 with Termidor as control agent, we advise re-treatment to perimeter areas due to age of previous barrier

Completed in 2021

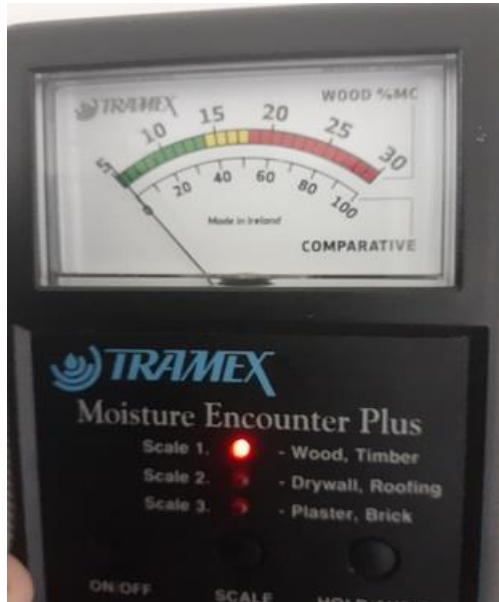
No evidence was found.

at time of inspection moisture meter did not detect any high moisture levels within cavity walls

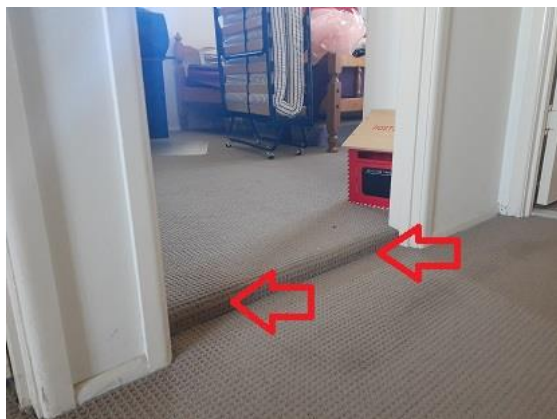
at time of inspection all weep holes were exposed at time of inspection, no inspection to below bedroom flooring due to carpet areas.

Raised slab areas due to false timber flooring installed and covered bedroom area

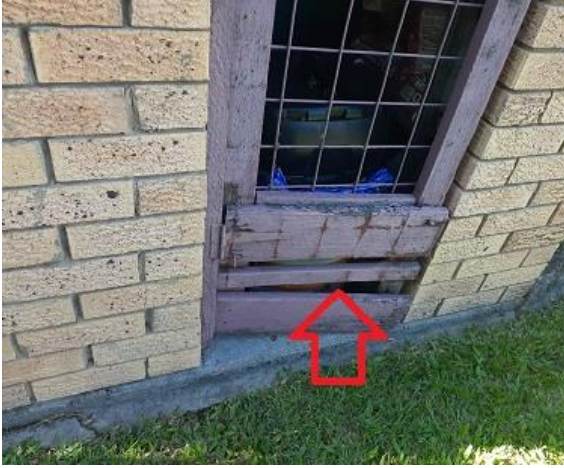
Decay noted in rear garden shed door frame as per below.

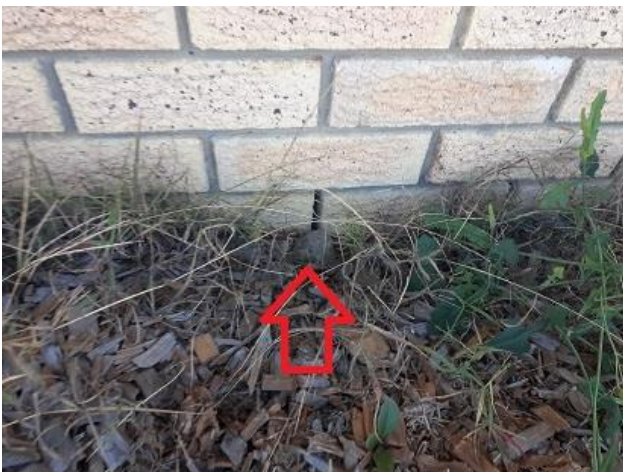
All perimeter gardens and soil next to brickwork considered conducive.

Garden beds against property considered conducive, we advise to expose all perimeter weep holes on perimeter at least 50 -100mm from gardens.
