Building Inspection Report

8 / 39 Kirkland Ave

Coorparoo Qld

Pre-Purchase Inspection - Residential Building Report

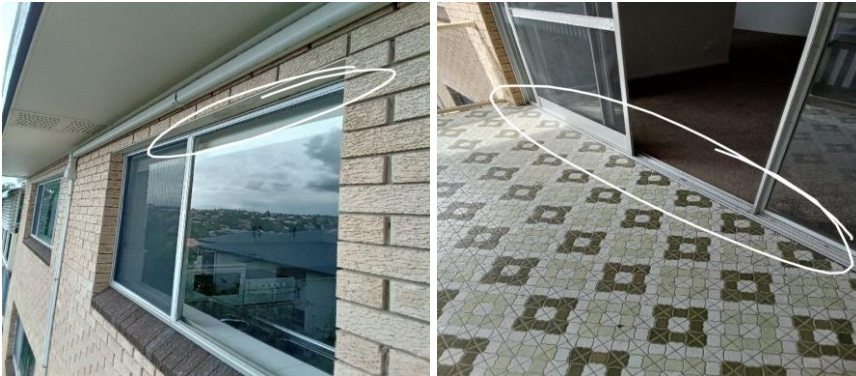
Minor surface corrosion to window lintel

Lack of step between i side and outside floor height.

Lintels: Defects/Safety Hazards found were: There is evidence of minor surface corrosion to the metal lintels supporting the window openings in places. It is recommended to mechanically remove the corrosion prior to the application of an appropriate zinc primer.

The finished surface height of the balcony is not stepped down from the internal floor height. As a result, water during extreme weather events may penetrate into the internal floor surface through the base of the sliding door joinery. It is recommended to consult a qualified, licensed and experienced builder for further advice on possible solutions.

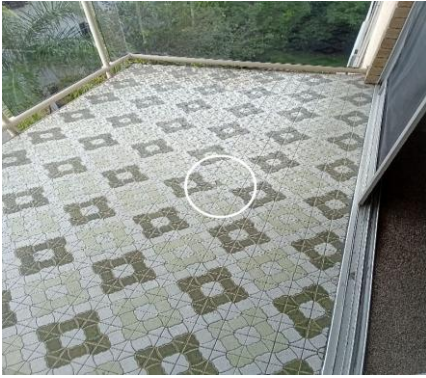
Damaged floor tile.

Balcony: Defects/Safety Hazards found were: One of the floor tiles is damaged and partially detached. Patching the void left from the missing tile is recommended.

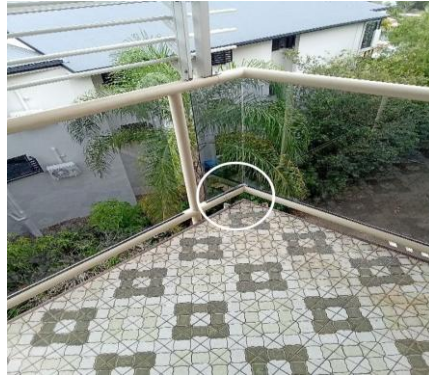
Partial detachment of rubber seal.

The rubber seal placed along the base of the aluminium balustrade has partially detached. Re-attachment is recommended.

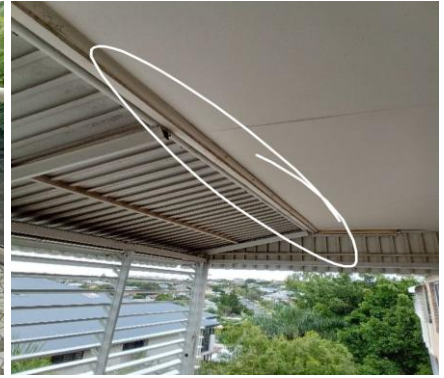
Partial detachment of timber trim.

The timber trim along the eaves lining has partially detached. Re-attachment is recommended prior to the next scheduled painting of the eaves lining.

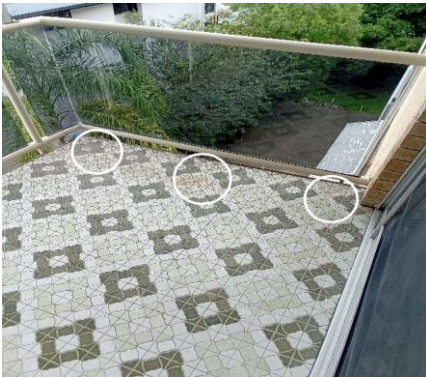
Discarded fixing holes on floor.

There are numerous minor discarded fixing holes along the floor tile surface near the side balustrade. Minor patching is recommended.

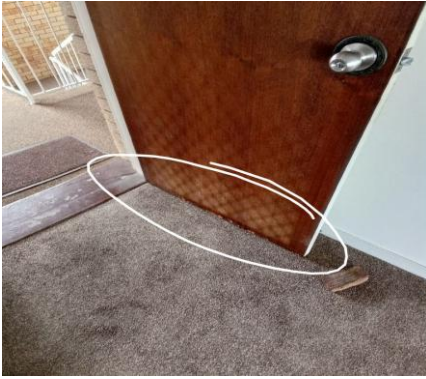
Minor deterioration to base of door.

Entry: Defects/Safety Hazards found were: There is minor deterioration to the base of the external façade of the front door. It is recommended to ensure that the base of the door is consistently sealed with a quality oil-based sealant at all times to prevent further deterioration.

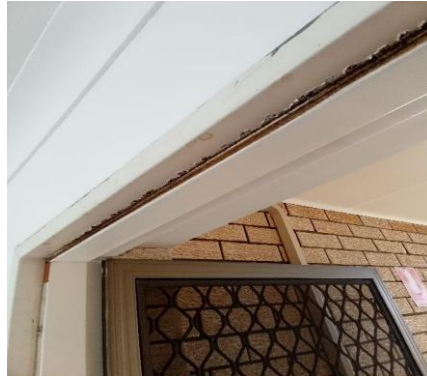
Surface corrosion to metal door frame.

There is evidence of minor surface corrosion to the metal door frame in places. It is recommended to mechanically remove the corrosion prior to the application of an appropriate zinc primer.

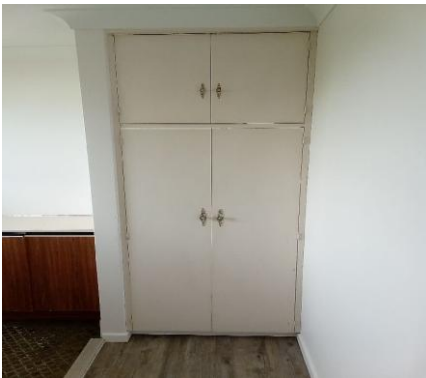
Cupboard doors binding against each other.

Linen Cupboard: Defects/Safety Hazards found were: The linen cupboard doors are rubbing against each other. Therefore, it is recommended to engage a qualified, licensed and experienced carpenter to adjust the doors to achieve an even margin so they may open freely as intended.

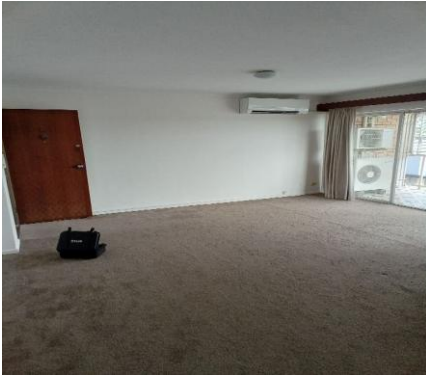
Drummy wall render.

Lounge Room: Defects/Safety Hazards found were: The solid render wall surface has delaminated and become drummy in numerous locations throughout the unit. At present, the rendered surface is fit for purpose. However, care should be taken when installing mechanical fixings to the wall surface. Some detachment may occur.

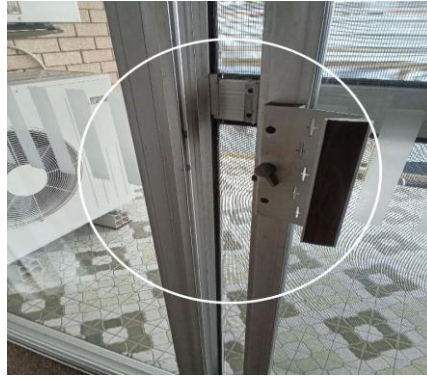
Lock not latching closed against frame.

The sliding door lock is not latching closed against the fixed door panel. It appears that the latch requires repair or replacement in order to appropriately latch closed. It is recommended to engage a qualified, licensed and experienced glazier to provide further advice on repair.

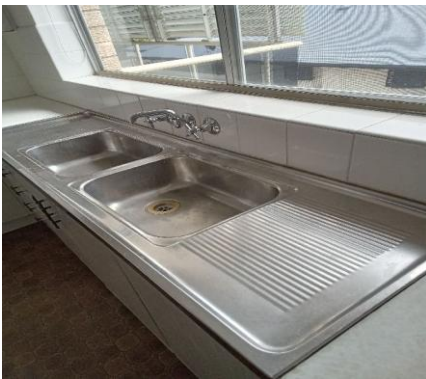
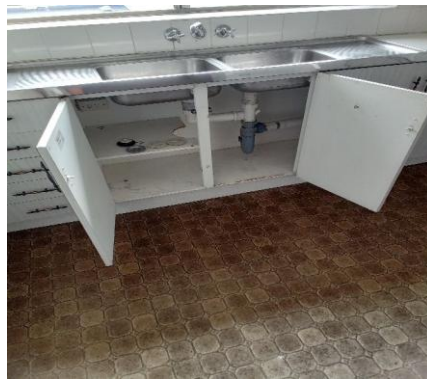
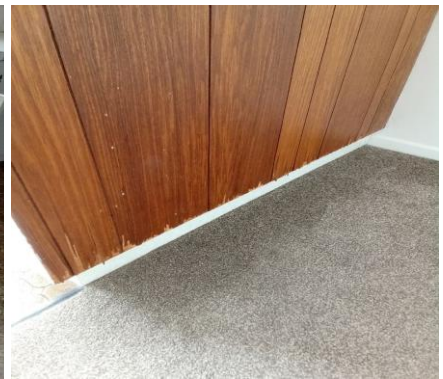
Kitchen: Defects/Safety Hazards found were: There are some marks / chips to the benchtop surface in places. However at present, the benchtop is fit for purpose.

It is recommended to replace the flexible sealant along the benchtop / splashback tile intersection.

There is evidence of minor water / moisture penetration to the laminate benchtop joints in places. However at present, the benchtop is fit for purpose.

The kitchen cabinets show evidence of exposure to water and humidity. At present, they are fit for purpose. However, replacement may be a consideration.

Some of the kitchen cabinet doors and drawers require minor adjustment for them to operate adequately and smoothly.

Some of the splashback wall tiles are drummy or loosely attached. It is recommended to engage a qualified, licensed and experienced tiler for further advice.

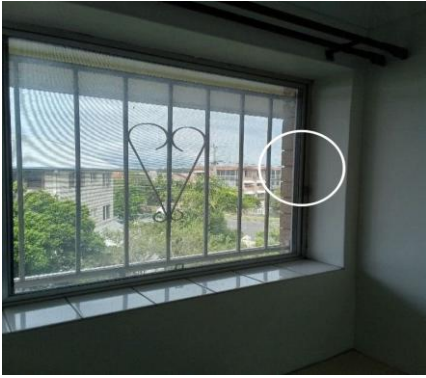
Window latch detached and missing.

Laundry: Defects/Safety Hazards found were: The sliding window latch is detached and missing. It is recommended to engage a qualified, licensed and experienced glazier to provide further advice on repair.

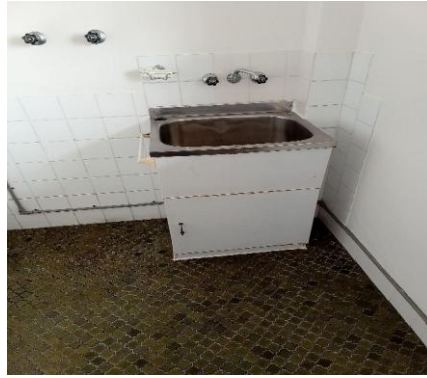
Minor surface corrosion to laundry tub.

The laundry tub cabinet has some evidence of corrosion in places. However at present, it is fit for purpose.

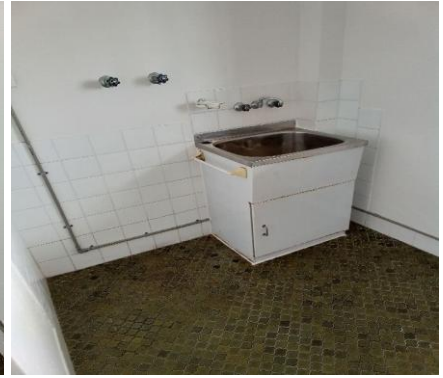
Drummy wall tiles.

Some of the splashback wall tiles are drummy or loosely attached. It is recommended to engage a qualified, licensed and experienced tiler for further advice.

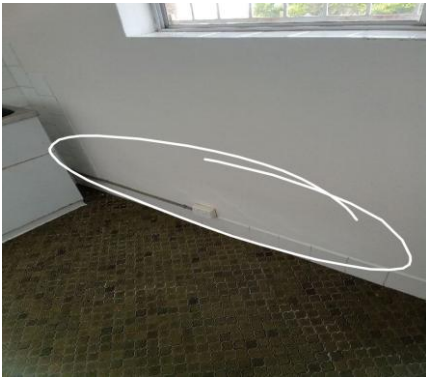
Delamination of render from base of wall.

The solid render finish along the base of the wall has delaminated from the brickwork and distorted outwards. At present, it remains together. However, minor disturbance will cause it to break apart. It is recommended to engage a qualified, licensed and experienced solid renderer for further advice on repair.

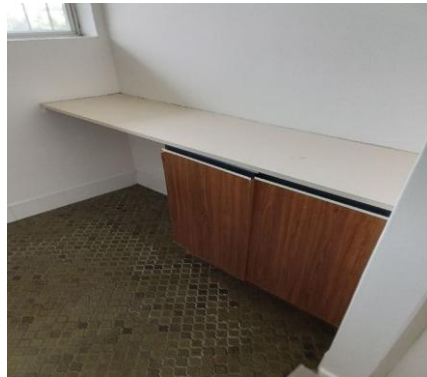
Significant deterioration due to moisture penetration.

There is evidence of significant deterioration due to water / moisture penetration to the cabinet joinery. Replacement may be a consideration.

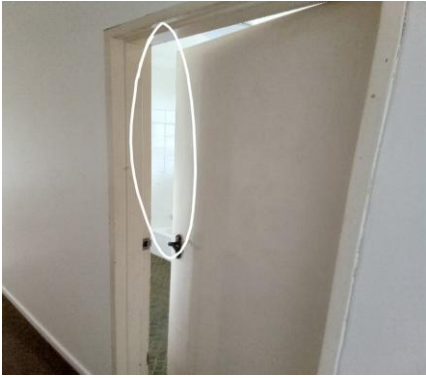
Door rubbing on frame.

Bathroom: Defects/Safety Hazards found were: The door is rubbing against the side of the metal door jamb. Therefore, it is recommended to engage a qualified, licensed and experienced carpenter to adjust the door to achieve an even margin so it may open freely as intended.

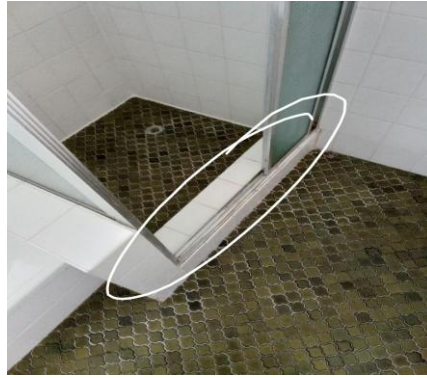
Shower screen installed inappropriately.

The shower screen door assembly has been installed over the outside edge of the shower hob. This may allow water to escape the shower enclosure. Relocation of the shower screen to the inside edge of the hob is recommended.

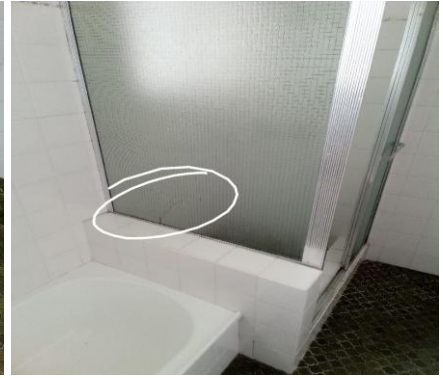
Cracked shower screen.

The shower screen fixed panel glass is cracked, Replacement is required.

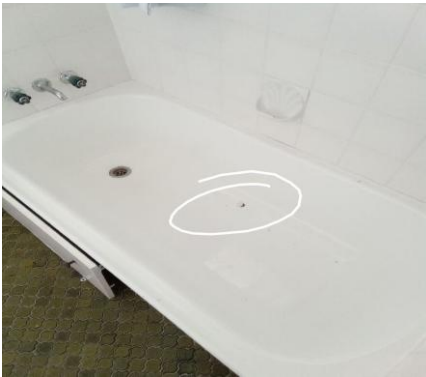
Damage to bath enamel.

The bath enamel is chipped in places. It is recommended to engage a qualified bath repair specialist to repair the minor damage to prevent further deterioration of the bath enamel surface.

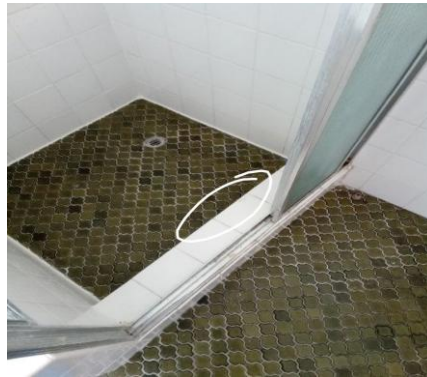
Damaged tile on hob.

Some of the shower enclosure wall tiles are cracked and damaged. It is recommended to engage a qualified, licensed and experienced tiler for further advice.

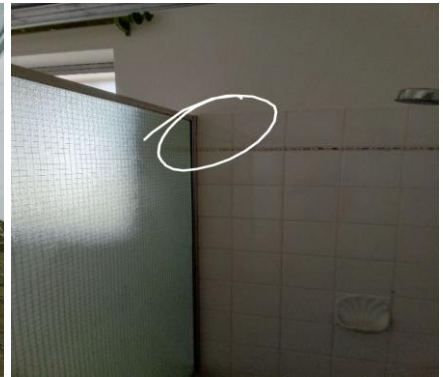
Cracked wall tile.

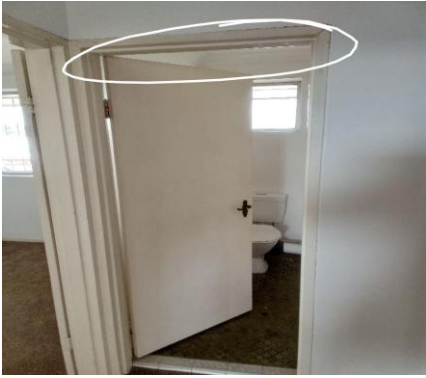
Door rubbing on top of jamb.

WC: Defects/Safety Hazards found were: The door is rubbing against the top of the metal door jamb. Therefore, it is recommended to engage a qualified, licensed and experienced carpenter to adjust the door to achieve an even margin so it may open freely as intended.

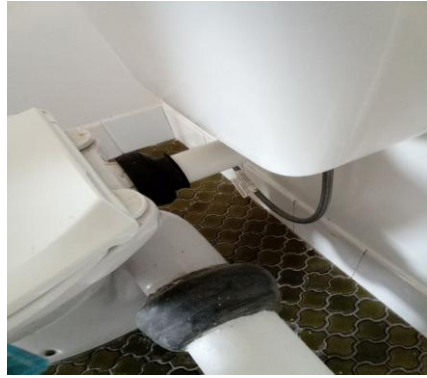
Rubber flush pipe seal brittle.

The toilet cistern flush pipe rubber seal appears to have some deterioration. It is recommended to replace the seal.

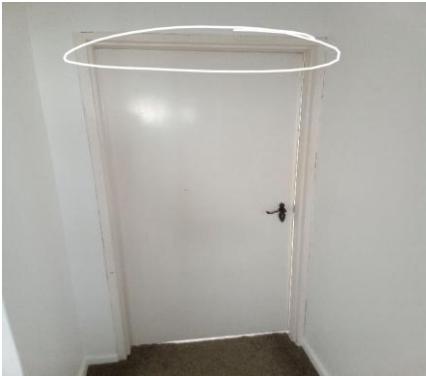
Door rubbing on head.

Bedroom 1: Defects/Safety Hazards found were: The door is rubbing against the top of the metal door jamb. Therefore, it is recommended to engage a qualified, licensed and experienced carpenter to adjust the door to achieve an even margin so it may open freely as intended.

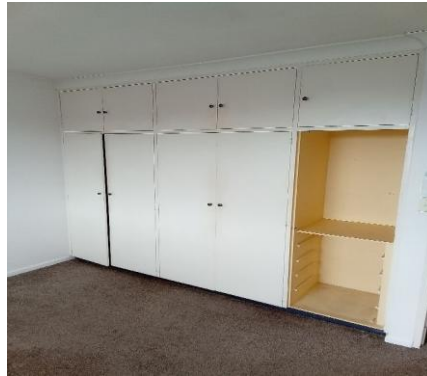
Cupboard doors binding against each other.

The robe cupboard doors are rubbing against each other. Therefore, it is recommended to engage a qualified, licensed and experienced carpenter to adjust the doors to achieve an even margin so they may open freely as intended.

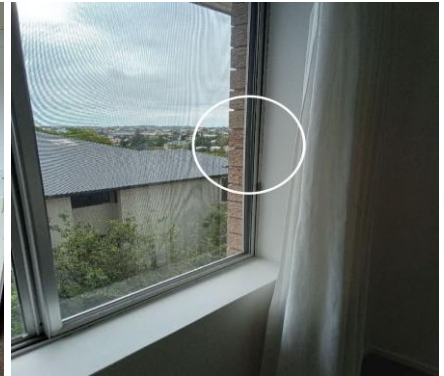
Window latches are detached and missing.

The sliding window latches are detached and missing. It is recommended to engage a qualified, licensed and experienced glazier to provide further advice on repair.

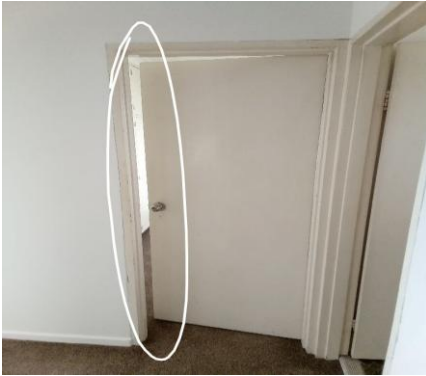
Door binding on jamb.

Bedroom 2: Defects/Safety Hazards found were: The door is rubbing against the side of the metal door jamb. Therefore, it is recommended to engage a qualified, licensed and experienced carpenter to adjust the door to achieve an even margin so it may open freely as intended.

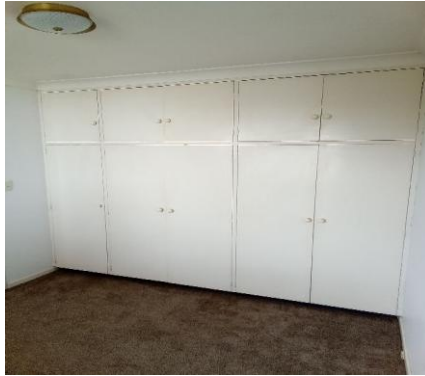
Cupboard doors binding against each other.

The robe cupboard doors are rubbing against each other. Therefore, it is recommended to engage a qualified, licensed and experienced carpenter to adjust the doors to achieve an even margin so they may open freely as intended.

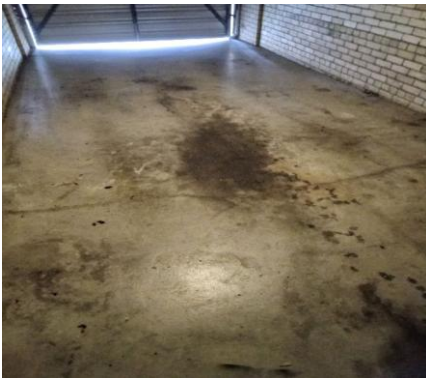
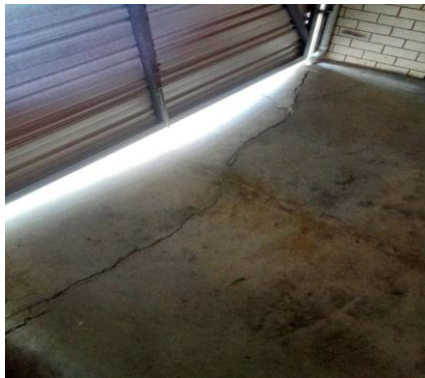
Garage: Defects/Safety Hazards found were: There are some cracking defects to the concrete floor surface consistent with shrinkage and settlement cracking. These cracking defects are within expected tolerances for the age and type of construction used.

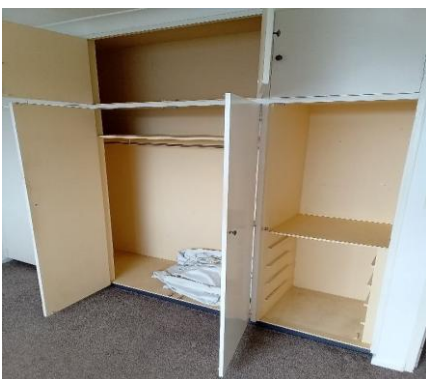
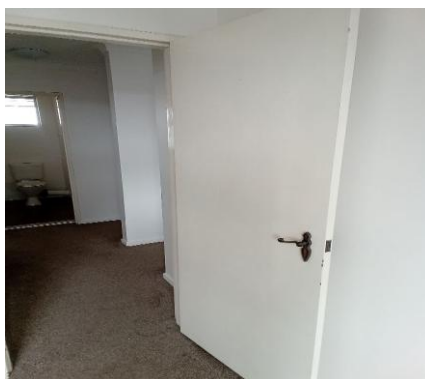
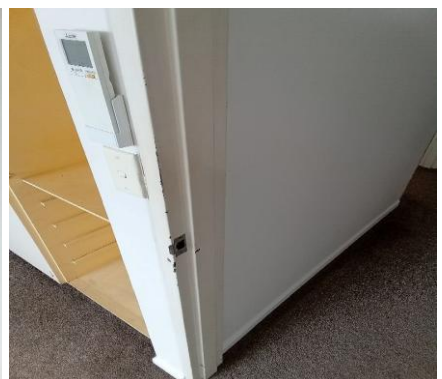
Other if Applicable: Other Defects/Safety Hazards found were: The main area walls and ceilings have been recently painted. However, the remainder of the unit is to the existing finish. Further preparation and painting is required for a consistent finish throughout the unit.
