# BUILDING CONSTRUCTION MATERIALS LISTING

### PROPERTY DETAILS

LAUREL VIEW CTS 9008  
34 CORDEAUX STREET  
WEST END, QLD, 4101

**Inspection Date:** 9/01/2019

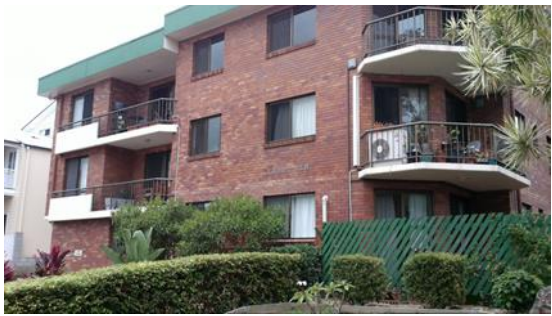
<b>Building No:</b>	Laurel View CTS 9008		
<b>Unit numbers:</b>	1	to	7
<b>Approximate year of construction:</b>	1984		
<b>Number of Levels:</b>	3		
<b>Complex Type:</b>	Residential		
<b>Fencing Type:</b>	Painted timber paling		
<b>External Walls:</b>	Brick	95%

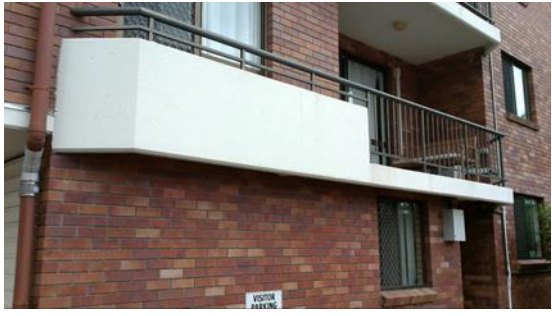
Concrete	4%

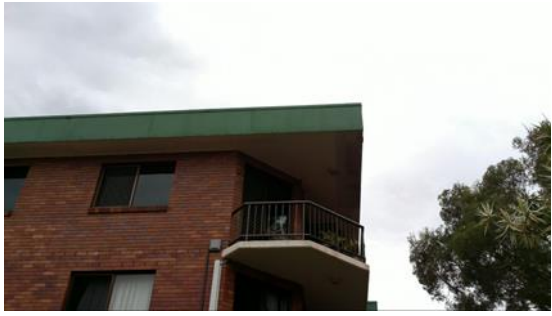
AC Sheeting (Assumed)	1%
