Building Inspection Report

8 / 39 Kirkland Ave

Coorparoo Qld

Pre-Purchase Inspection - Residential Building Report

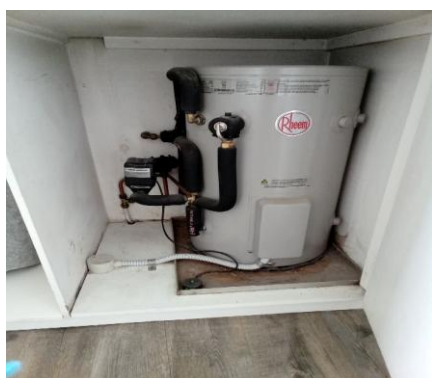
Hot Water Service:

All hot water services need to be inspected and reported on by a plumber and/or electrician. It's recommended that a licensed plumber and/or electrician be consulted for further advice.
