# BUILDING CONSTRUCTION MATERIALS LISTING

### PROPERTY DETAILS

LAUREL VIEW CTS 9008  
34 CORDEAUX STREET  
WEST END, QLD, 4101

**Inspection Date:** 9/01/2019

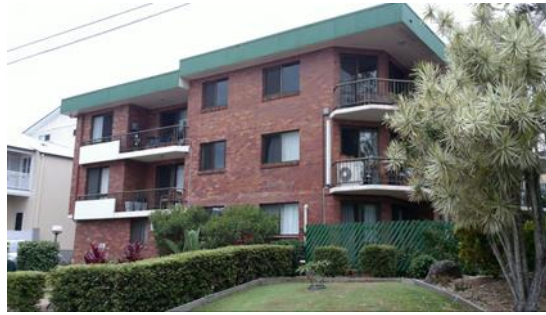
<b>Building No:</b>	Laurel View CTS 9008		
<b>Unit numbers:</b>	1	to	7
<b>Approximate year of construction:</b>	1984		
<b>Number of Levels:</b>	3		
<b>Complex Type:</b>	Residential		
<b>Fencing Type:</b>	Painted timber paling		
<b>External Walls:</b>	Brick	95%
